# PHASE I INSPECTION REPORT

## NATIONAL DAM SAFETY PROGRAM

NAME OF DAM: SPRING LAKE DAM  
LOCATION: WARREN COUNTY, VIRGINIA  
INVENTORY NUMBER: VA. NO. 18703

Name of Dam: Spring Lake Dam  
State: Virginia  
Location: Warren County  
USGS Quad Sheet: Linden  
Coordinates: Lat 38° 59.1' Long 78° 02.1'  
Stream: Tributary of Venus Branch  
Date of Inspection: May 5, 1981

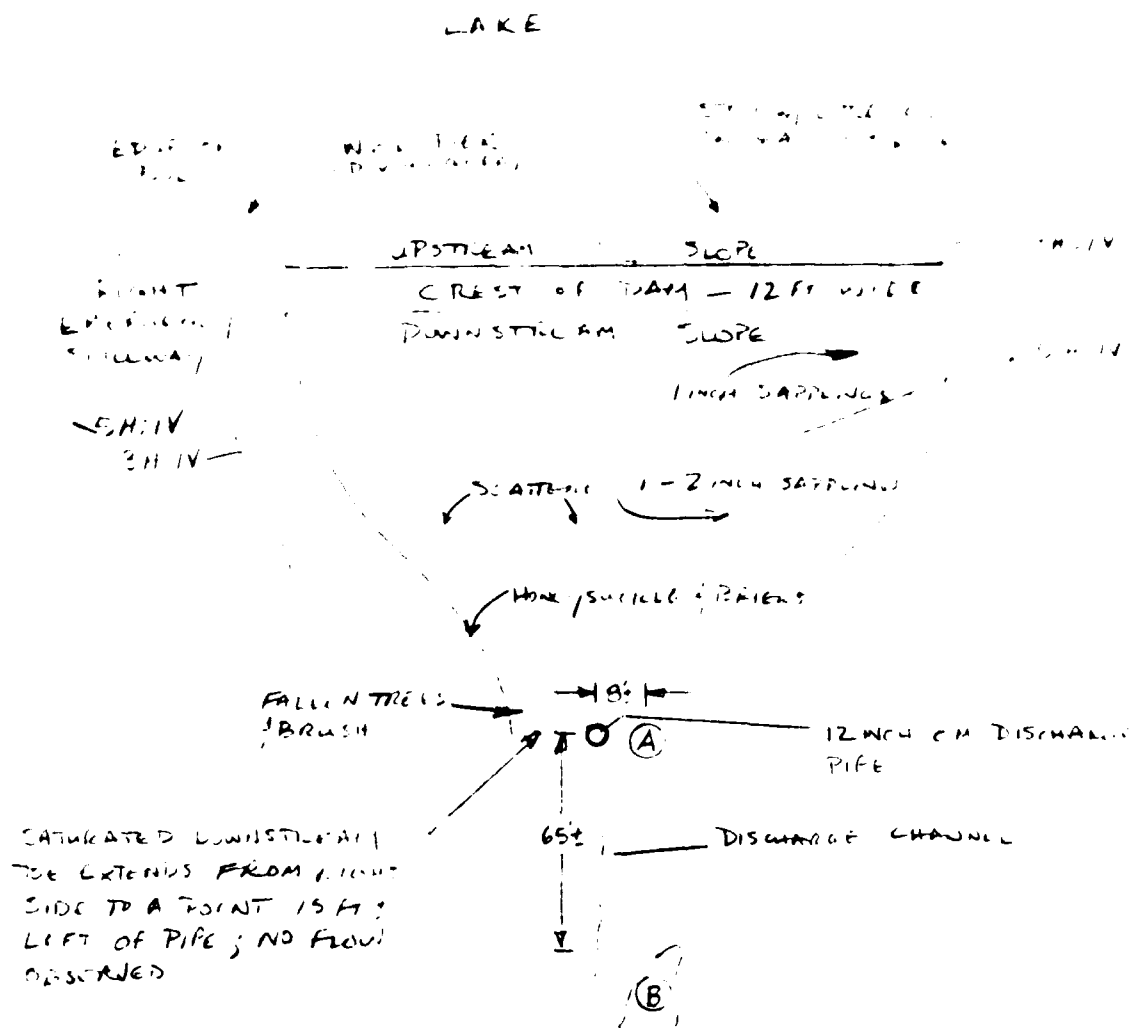
The saturated ground condition present along the downstream toe is believed to be related to flow from the toe drain(s) and also seepage through the dam. Attempts should be made to locate the toe drain outlet(s) and remove any cover material, so as to allow free flow. The two stained areas observed adjacent to and below the discharge pipe are believed to be related to seepage through the dam even though no flow was observed. This does not necessarily create an unsafe condition; however, these areas should be monitored periodically in attempt to detect any significant increases in flow which may result in piping within the embankment.

(A) RED IRON STAINED SEC-PAGE; NO FLOW OBSERVED.

(B) RED IRON STAINED PONDED AREA 40 FT ± LONG AND 10 FT ± WIDE; NO FLOW OBSERVED.

Vehicular traffic should be restricted on the dam and bare areas on the embankment crest should be reseeded. The toe drain outlet(s) should be located, uncovered and allowed to flow freely. The two iron stained wet areas located to the left of and below the principal spillway discharge outlet should be monitored quarterly to detect any flow which could cause

pipng in the embankment. If increased flows should occur, a geotechnical engineering consultant should be engaged to evaluate the problem. Riprap should be placed below the principal spillway discharge outlet to restrict erosion during flooding. A staff gage should be installed to monitor water levels.
